SUBJECT: Review of boiler and soot blower design criteria

SUBJECT: Metallurgical Evaluation of Coal Burner Tip Failure

METALLURGICAL EVALUATION OF

COAL BURNER TIP

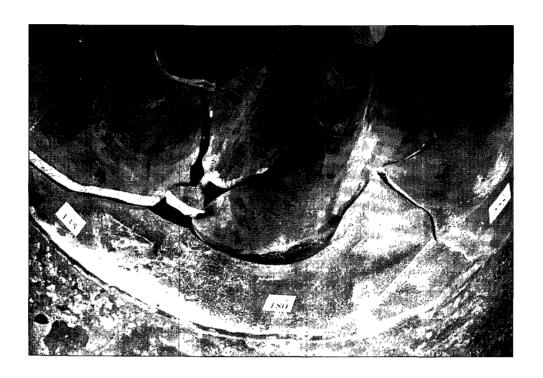
Fig. 5. Overall and close-up views of inside diameter surfaces of burner tip.

Close-up views of the inside diameter surfaces of the burner are provided in Figs. 5 through 7. Visual examination of the inside diameter surfaces confirmed that localized areas of the burner tip had undergone significant erosion wear.
